# MEDIA RELEASE

## Sinkhole repairs underway at Woodglen water storage basin

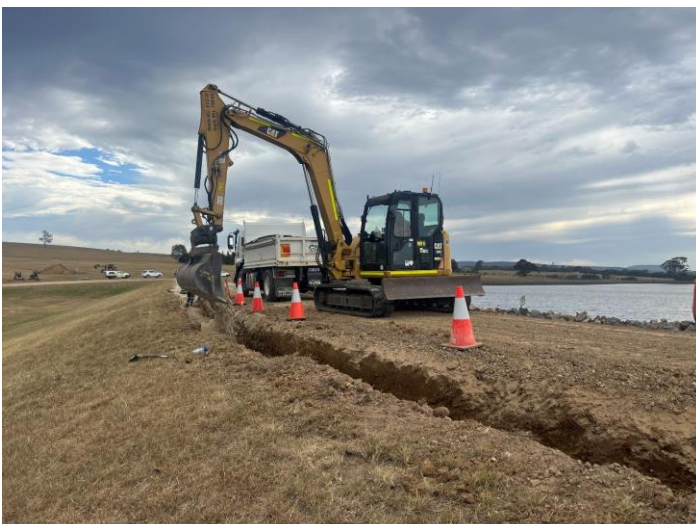
Image shows McInnes Earthmoving undertaking works on the sinkhole repairs at East Gippsland Water's Woodglen Water Treatment facility.

"The project is costing around \$500k and the works involve digging down approximately 1 to 1.5 metres to expose the existing sand chimney filter. This will then be raised to the full height of the basin, new sand material placed in the filter trench and mechanically compacted to a density that will protect the embankment to improve the safety of the basin.
